CAFO FACILITY INSPECTION REPORT

<u>8365950001</u> WDID NUMBER	<u>Geoffrey Vanden Heuvel</u> OWNER NAME	<u>J & D Star Dairy No. 1</u> FACILITY NAME
<u>CAG018001</u> NPDES NUMBER	Ex. 6 Personal Privacy (PP)	
<u>R8-2007-0001</u> RWQCB ORDER NO.	<u>Chino, CA 91710</u> OWNER CITY AND STATE	<u>Chino, CA 91710</u> FACILITY CITY AND STATE
<u>04/10/2013</u> SCHEDULED INSPECTION DATE	<u>Geoffrey Vanden Heuvel</u> OWNER CONTACT	<u>Geoffrey Vanden Heuvel</u> FACILITY CONTACT
<u>04/10/2013</u> ACTUAL INSPECTION DATE	Ex. 6 Personal Privacy (PP)	
<u>Santa Ana River</u> RECEIVING WATER	<u>Ex. 6 Personal Privacy (PP)</u> FACILITY LATITUDE	<u>Ex. 6 Personal Privacy (PP)</u> FACILITY LONGITUDE

On April 10, 2013, a Concentrated Animal Feeding Operation (CAFO) inspection was conducted for Santa Ana Water Board Order No. R8-2007-0001 - 'General Waste Discharge Requirements for Concentrated Animal Feeding Operations (Dairies and Related Facilities) within the Santa Ana Region', NPDES General Permit No. (CAG018001) at J & D Star Dairy No. 1 in Chino, California (refer to Photo 1). The inspector met with Mr. Geoffrey Vanden Heuvel (Owner, J & D Star Dairy No.1) at approximately 11:00 AM on April 10, 2013

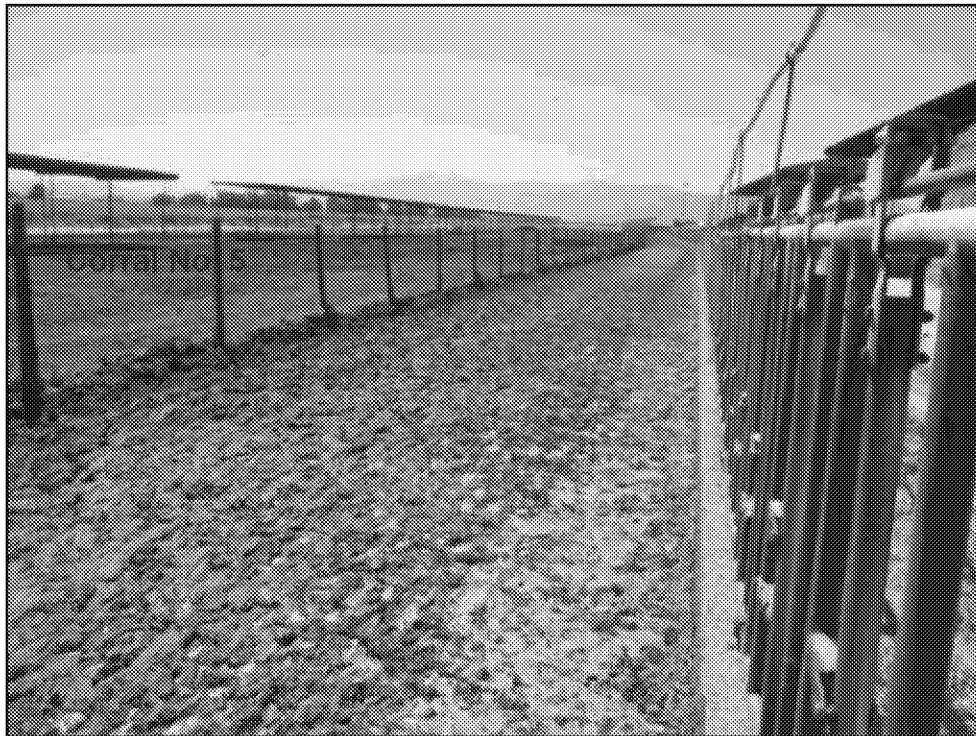
Mr. Vanden Heuvel stated that the corrals are cleaned three (3) to four (4) times per year and scraped every seven (7) to ten (10) days (refer to Photo 2). All manure is hauled offsite to Lewis Farms in Chino, California. Manure tracking manifests of all haul events during the 2012 reporting period were available for review at the time of the inspection. The most recent Nutrient Analysis was conducted on December 27, 2012. Mr. Vanden Heuvel stated that all mortalities are removed from the Facility immediately by Stiles Animal Removal, Inc.

Photograph 2. View facing southeast of corral No. 5. Mr. Vanden Heuvel stated corrals are typically cleaned three (3) to four (4) times per year, and scraped every seven (7) to ten (10) days.

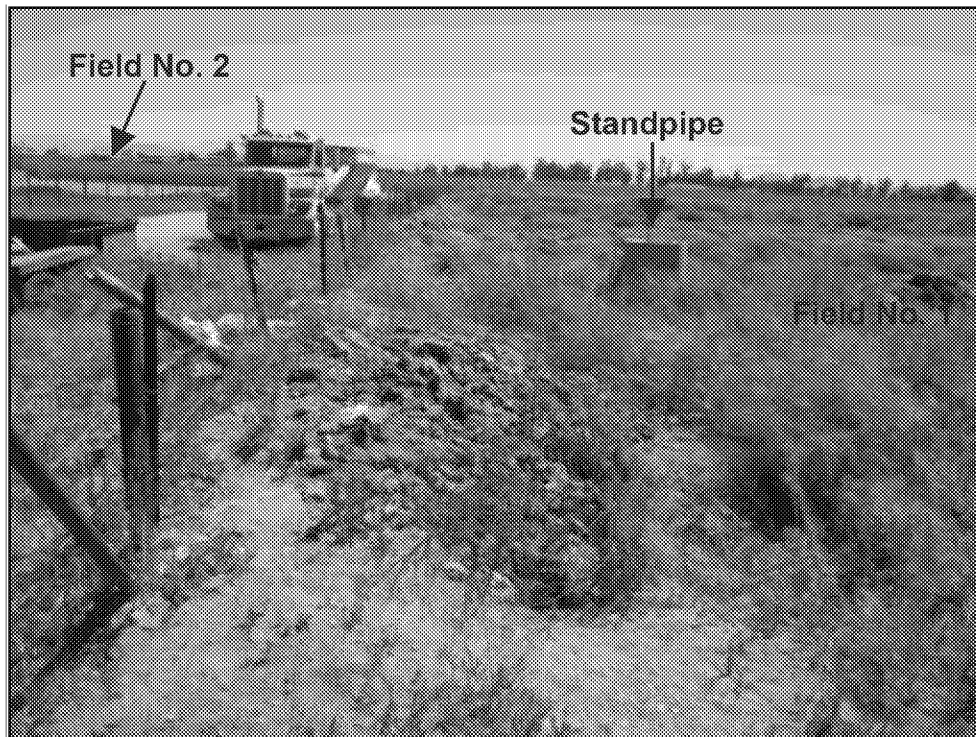
Photograph 3. View facing east of the process wastewater standpipe located in the northeast portion of field No. 1. The standpipe conveys process wastewater to multiple risers along the north side of the field for land application.

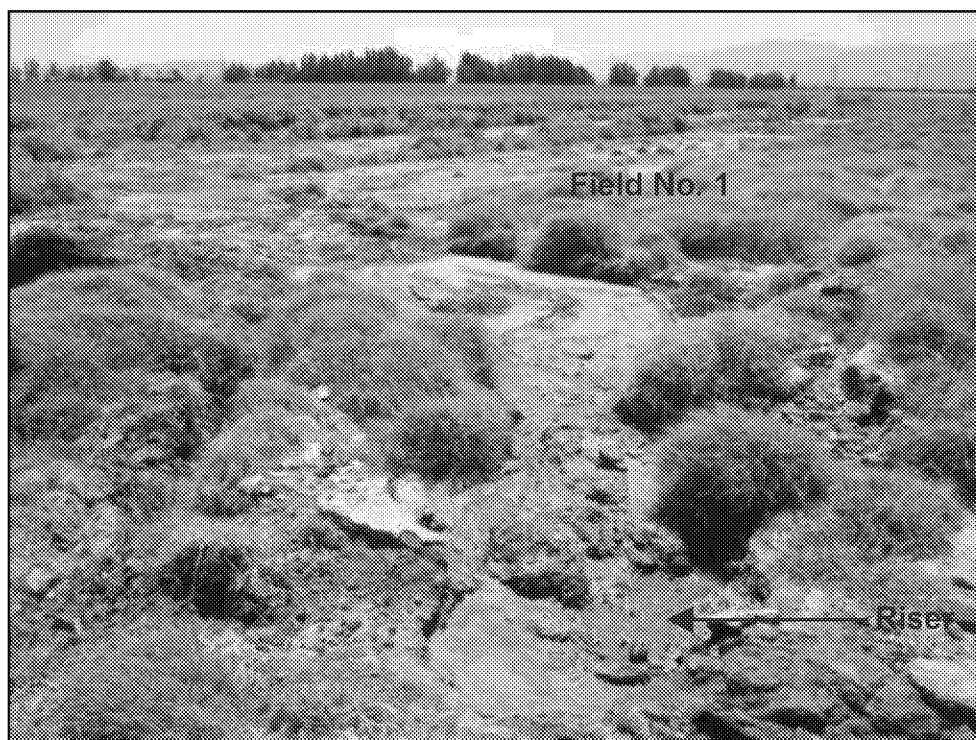
Photograph 4. View facing southeast of a riser actively releasing process wastewater onto the northeastern portion of field No. 1.

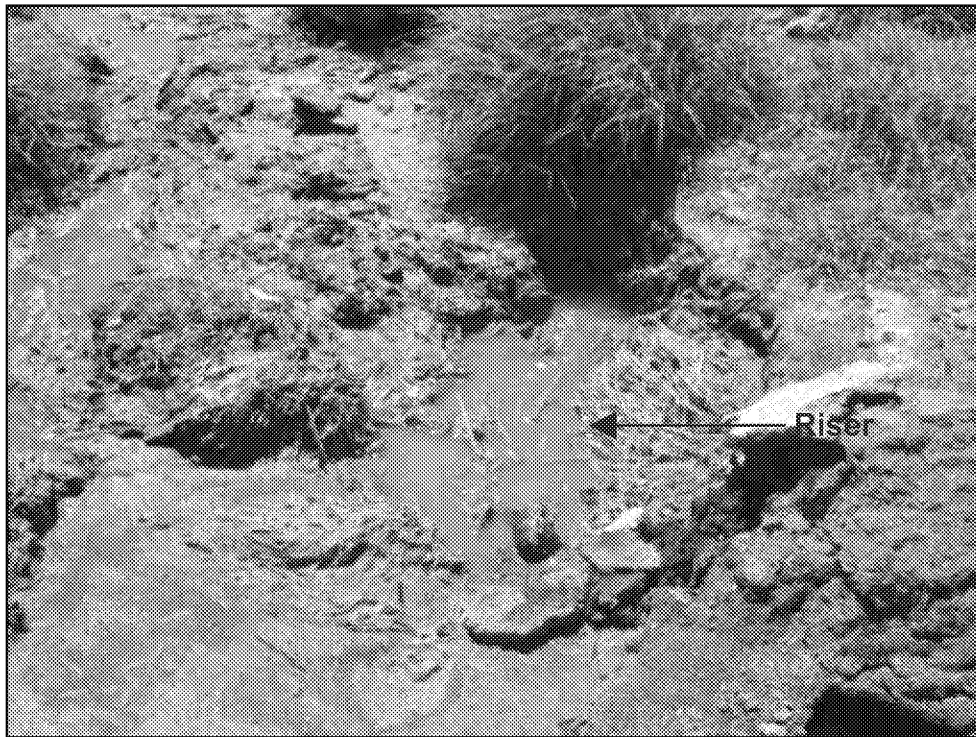
Photograph 5. Close-up view of the riser shown in Photograph 4.

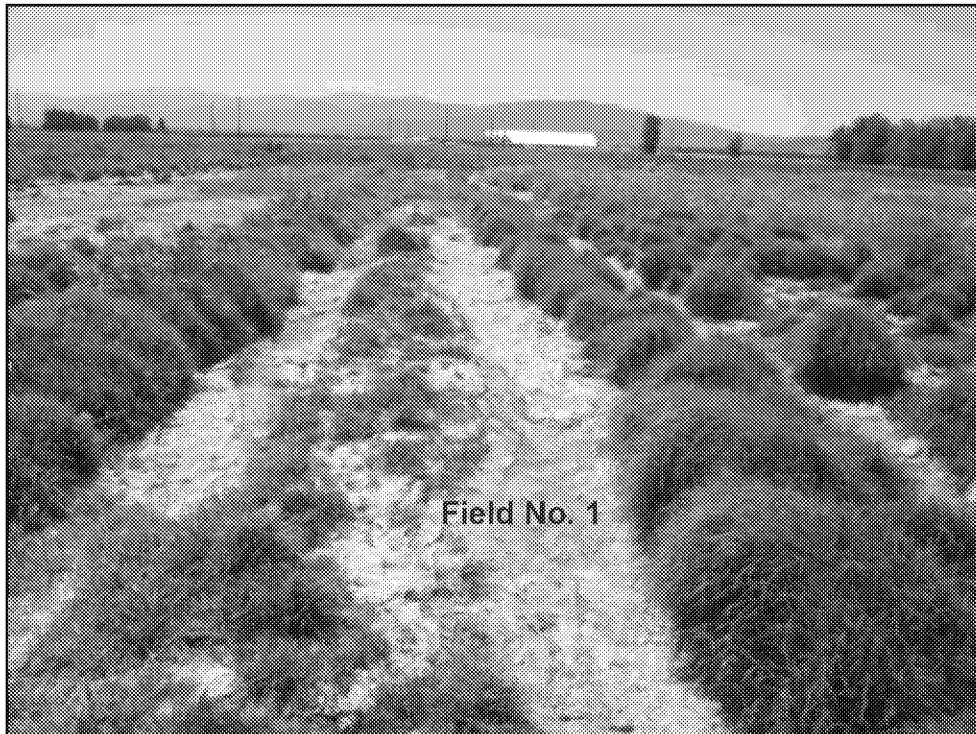
Photograph 6. View facing south of field No. 1. Note Mr. Vanden Heuvel stated the field is occasionally disked and that percolation rates are fast due to the sandy nature of the soil.

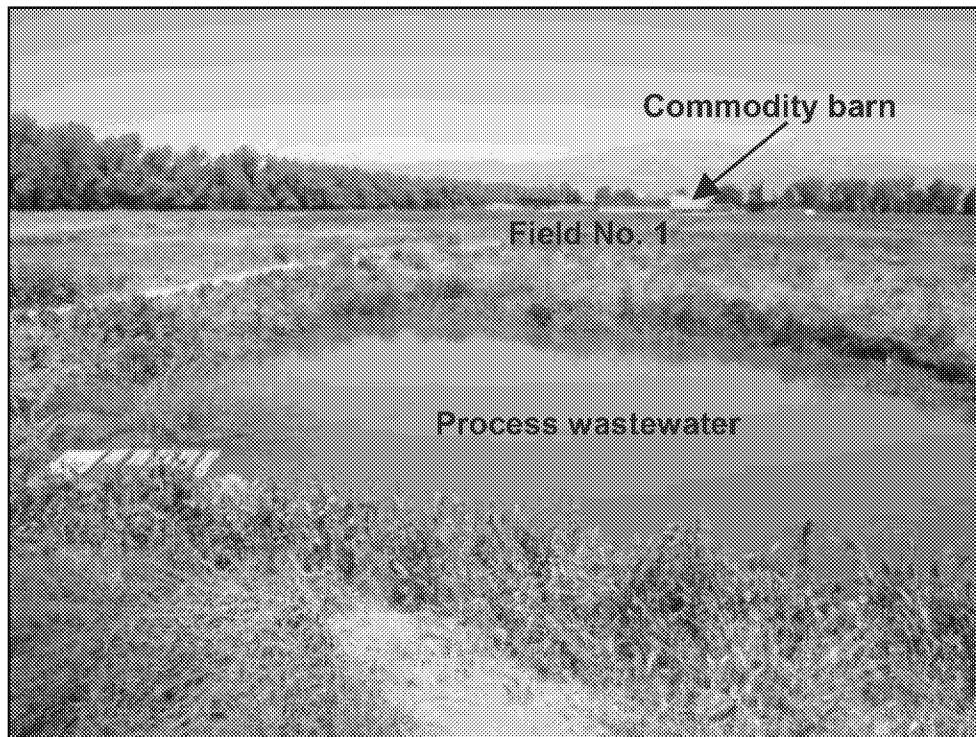
Photograph 7. View facing north of process wastewater accumulation on the southeast side of field No. 1. Note Mr. Vanden Heuvel stated process wastewater has never entered lagoon No. 1.

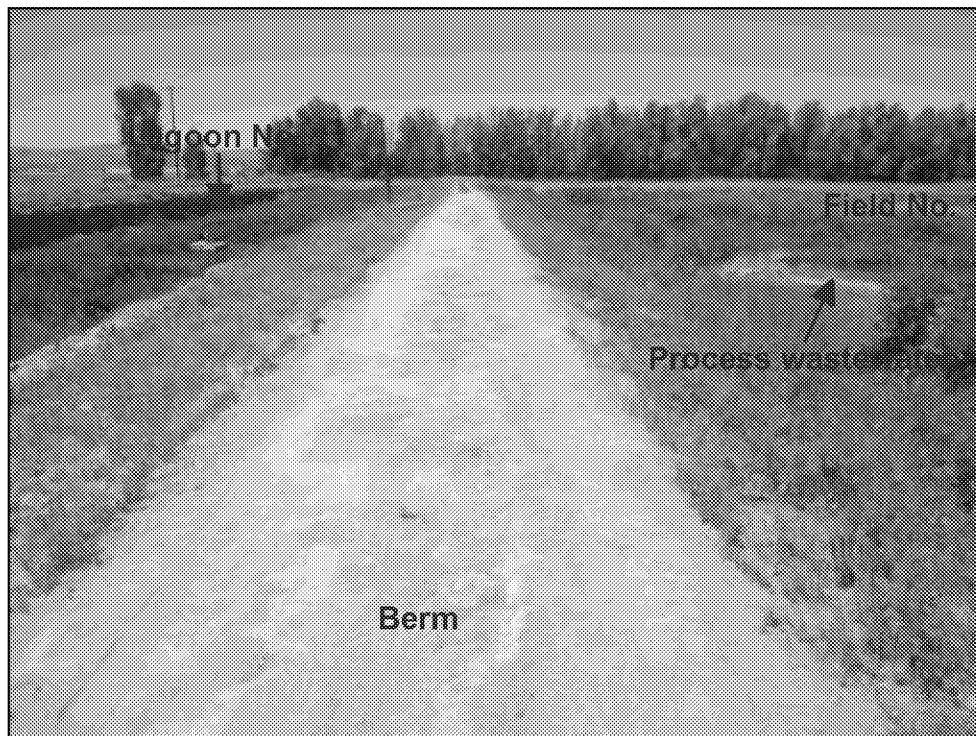
Photograph 8. View facing west of an earthen berm between the south side of field No. 1 and the north side of lagoon No. 1. Note Mr. Vanden Heuvel stated process wastewater has never entered lagoon No. 1. Also note the accumulated process wastewater on the south side of field No. 1, shown in Photograph 7.

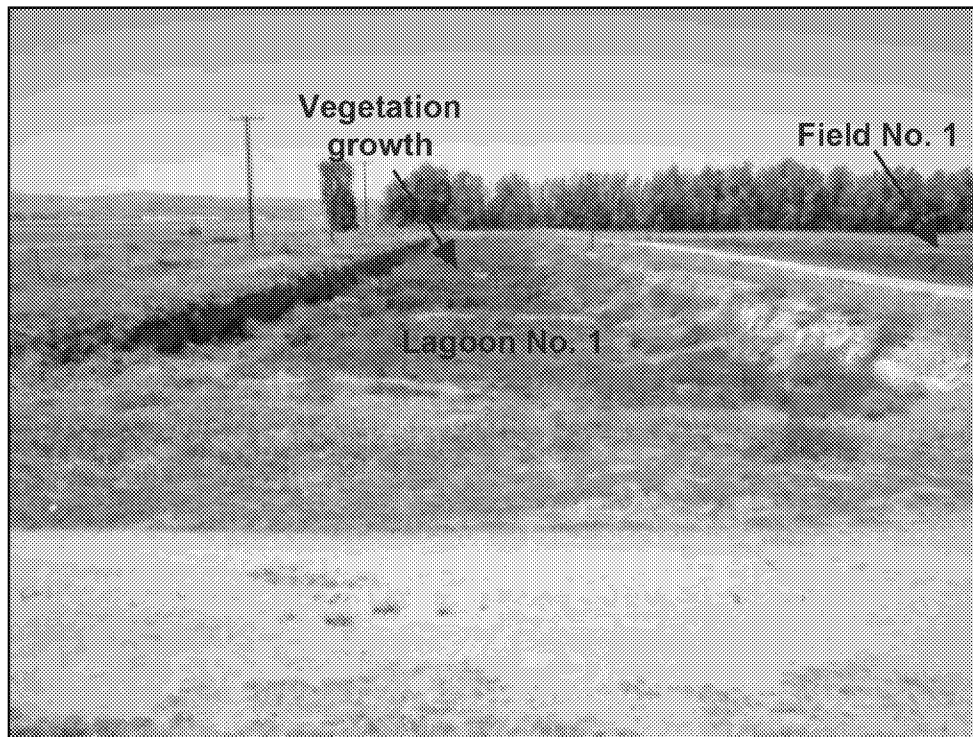
- Vegetation growth was observed in lagoon No. 1 in the southern portion of the Facility (refer to Photos 9, 10, and 11).

1. Vegetation growth was observed in lagoon No. 1 in the southern portion of the Facility (refer to Photos 9, 10, and 11). The Discharger must design and maintain all containment structures per the EWMP as required by Provision VII.C.3.a of the Permit.

1. The inspector observed, during the inspection, that vegetation growth potentially affecting the containment structure capacity was present in lagoon No. 1 located in the southern portion of the Facility (refer to Photos 9, 10, and 11). Mr. Vanden Heuvel stated that the lagoon has never been used and rarely accumulates storm water runoff; therefore, no maintenance has ever been performed on the pond. As a result of the vegetation growth, the overall capacity of the containment structures at the Facility may be diminished. The Discharger must design and maintain all containment structures per the EWMP as required by Provision VII.C.3.a of the Permit.

Photograph 9. View facing west of lagoon No. 1. Note vegetation growth was observed growing on the bottom of the lagoon.

1. Verify that vegetation growth is not diminishing the capacity of lagoon No. 1.

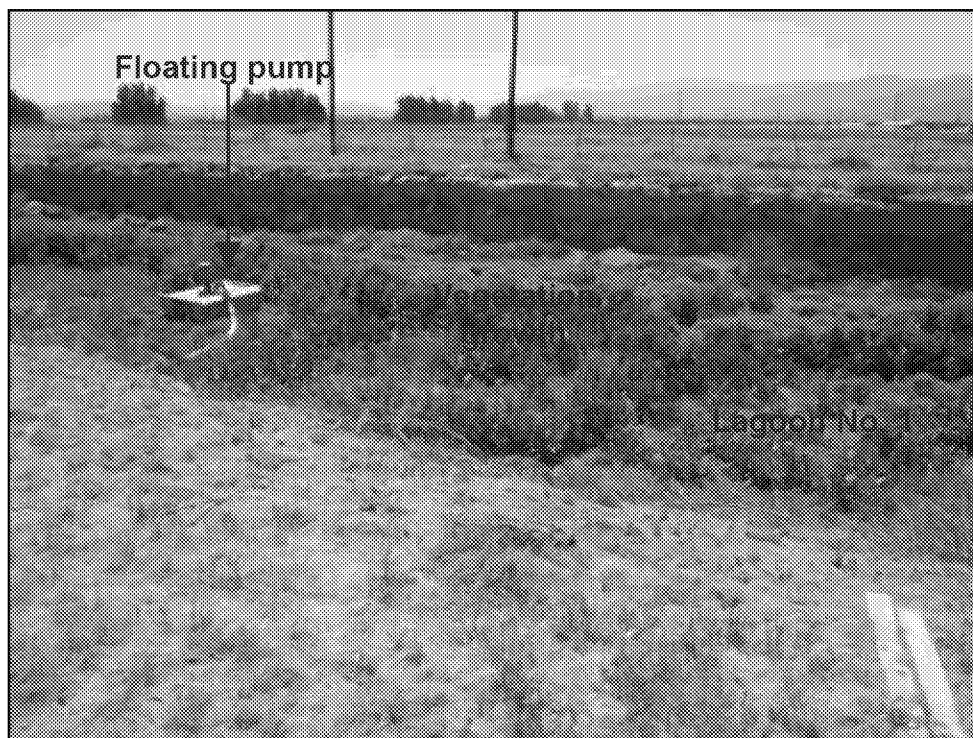
Photograph 10. View facing southeast of vegetation growth inside lagoon No. 1. Note the lagoon contained a floating pump.

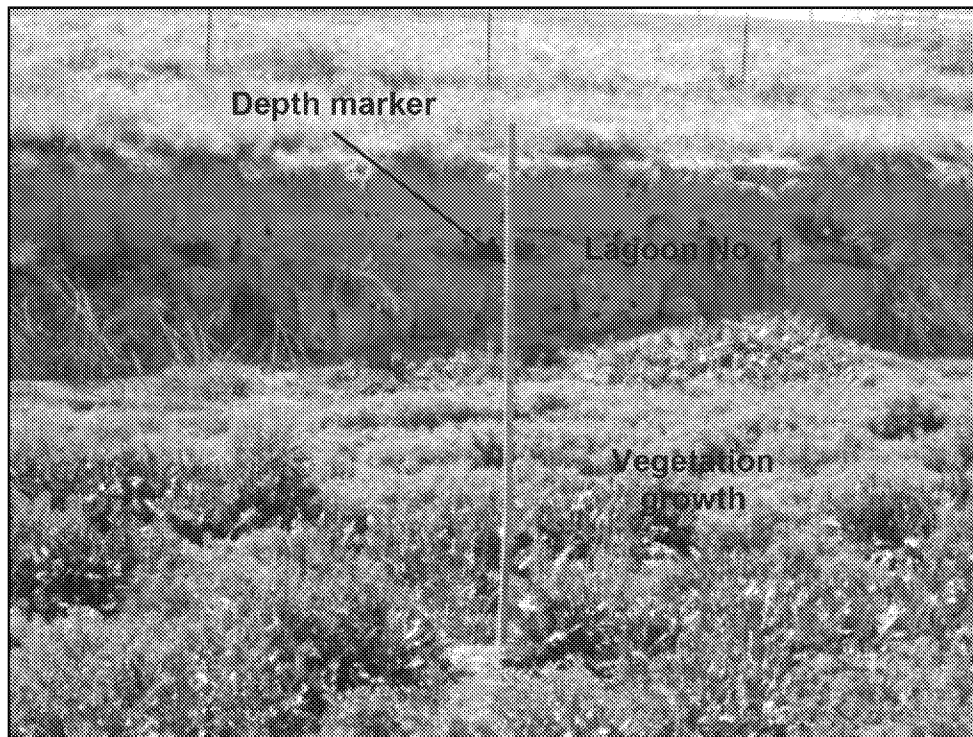
Photograph 11. View facing south of vegetation growth inside lagoon No. 1. Note the lagoon contained a depth marker.

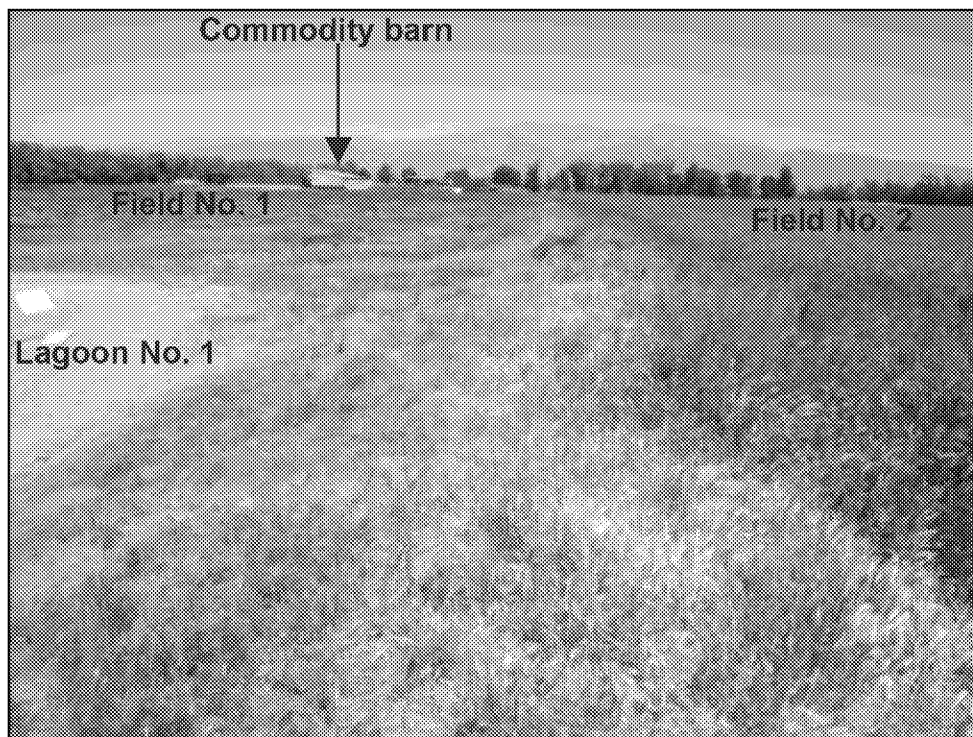
Photograph 12. View facing north of field Nos. 1 and 2. Note field No. 2 was currently being leased to Mr. Sam Lewis for crop production.

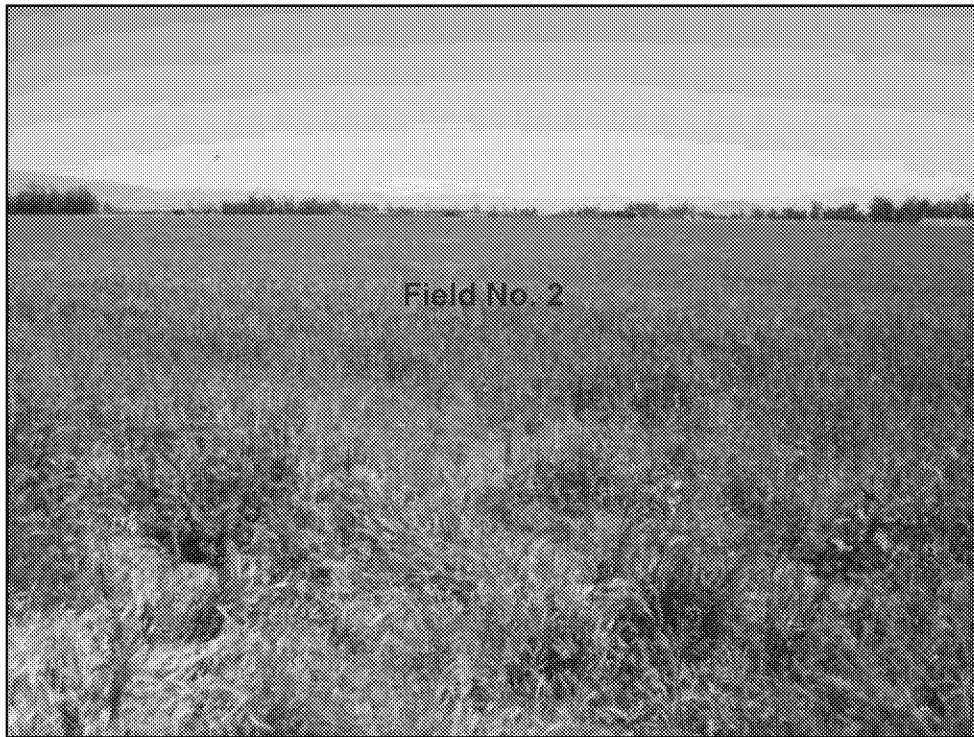
Photograph 13. View facing northeast of field No. 2 from the southwest corner of the field. Note field No. 2 was being leased to Mr. Sam Lewis for crop production at the time of the inspection.
